Client: Xxxxxxx Council

Site: Wyevale Court, xxxxxxxx xxxxx, xxxxxxxx
XXXXXXXXXXXXXXXX xxxx xxx

Document Title: Legionella Risk Assessments

Date: 12 November 2005

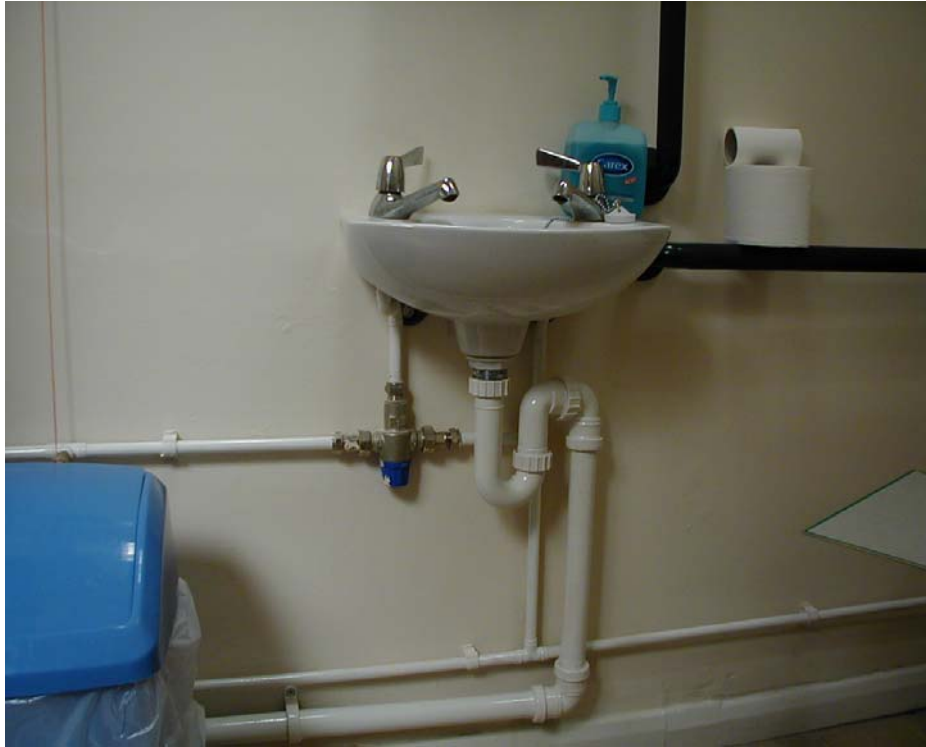
Disabled toilet on ground floor
Note the Type 3 TMV which does not function properly

- The cold water in the communal disabled toilets (see picture) fed from a Type 3 TMV was again recorded 32.4°C. This was probably caused by a faulty mixing valve.

- In four other locations the temperatures exceeded 20°C, some by a factor in excess of 20%.
- **Plumbing comment (rather than a legionella comment)**, the introduction of a new pressurised system has changed the operational parameters of the system. Hot water is percolating past the non-return valve and increase the temperature of the cold water supply.

- It is recommended that all TMV's are replaced at all locations with Type 2 TMV's compatible with the systems operation. **Estimated cost £xxxx**
- Introduce a regime of cleaning out the pressure vessels. **Estimated cost £xxxx**

- Install new TMVs to conform to local authority regulations. **Estimated cost £xxxx**

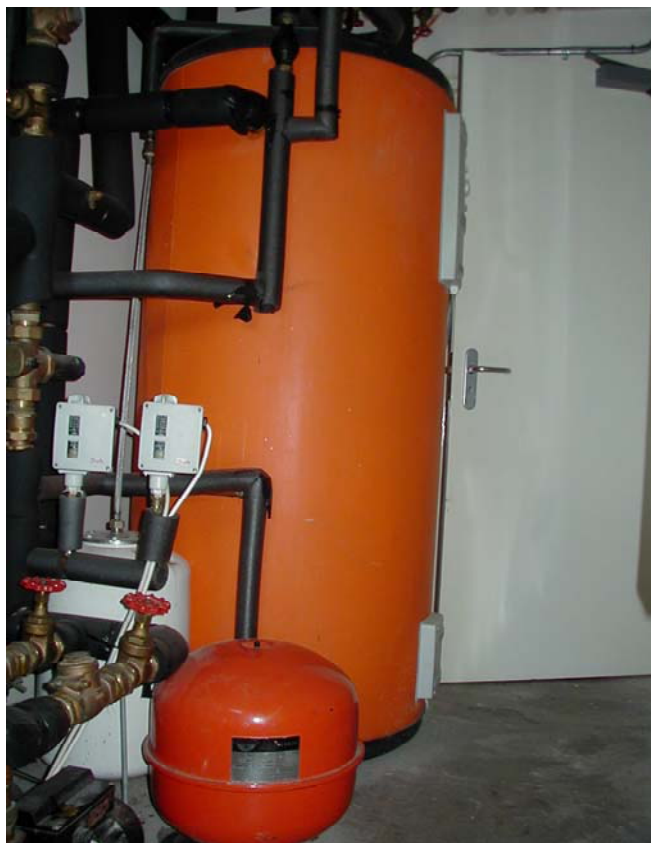
Hot water storage,
Ground floor with single storey above. Modern installation conforming to Water Regulations

< pressure vessel
